# 4.5l EFI Motor Flat Spot

All 4500 Petrol (gasoline) engined TLC 80 Series.

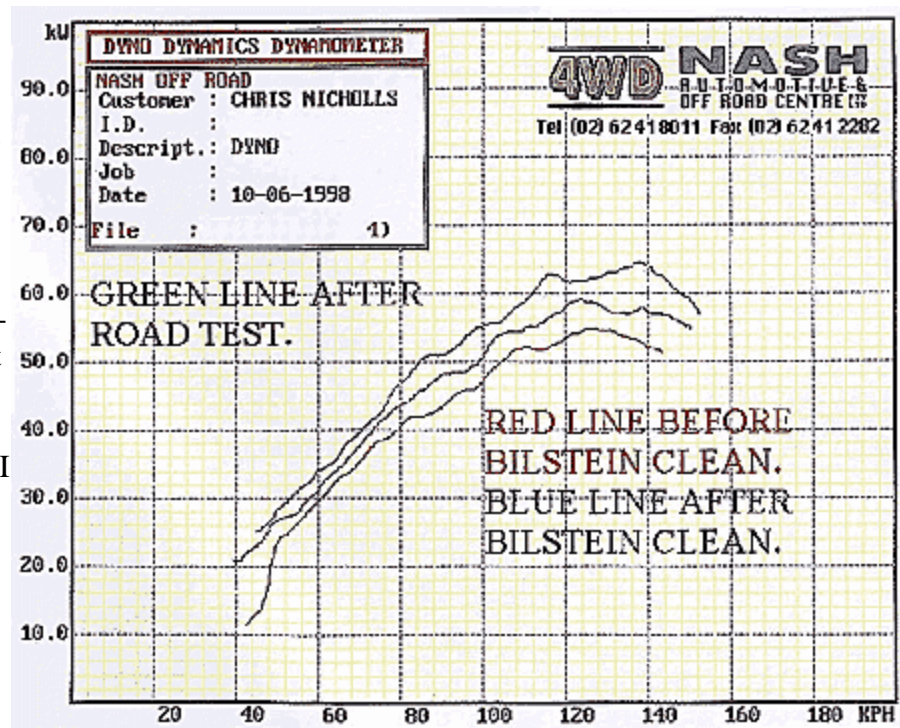
What I tried was a complete flush of the inlet and injector system. The effect was dramatic - I got a 10-12kW increase in power (see dynamometer test results) after the flush and after running a road test (20kms). Also the flat-spot disappeared for about three weeks... yes it did come back, but not nearly as dramatic nor as strong. I suspect if you had a series of these flushes it may disappear entirely.
