## **Acoustic and Thermal Liner – Land Cruiser 80 series**

Heres how to cut that heat by 90-95% and considerably lower internal noise as a bonus.

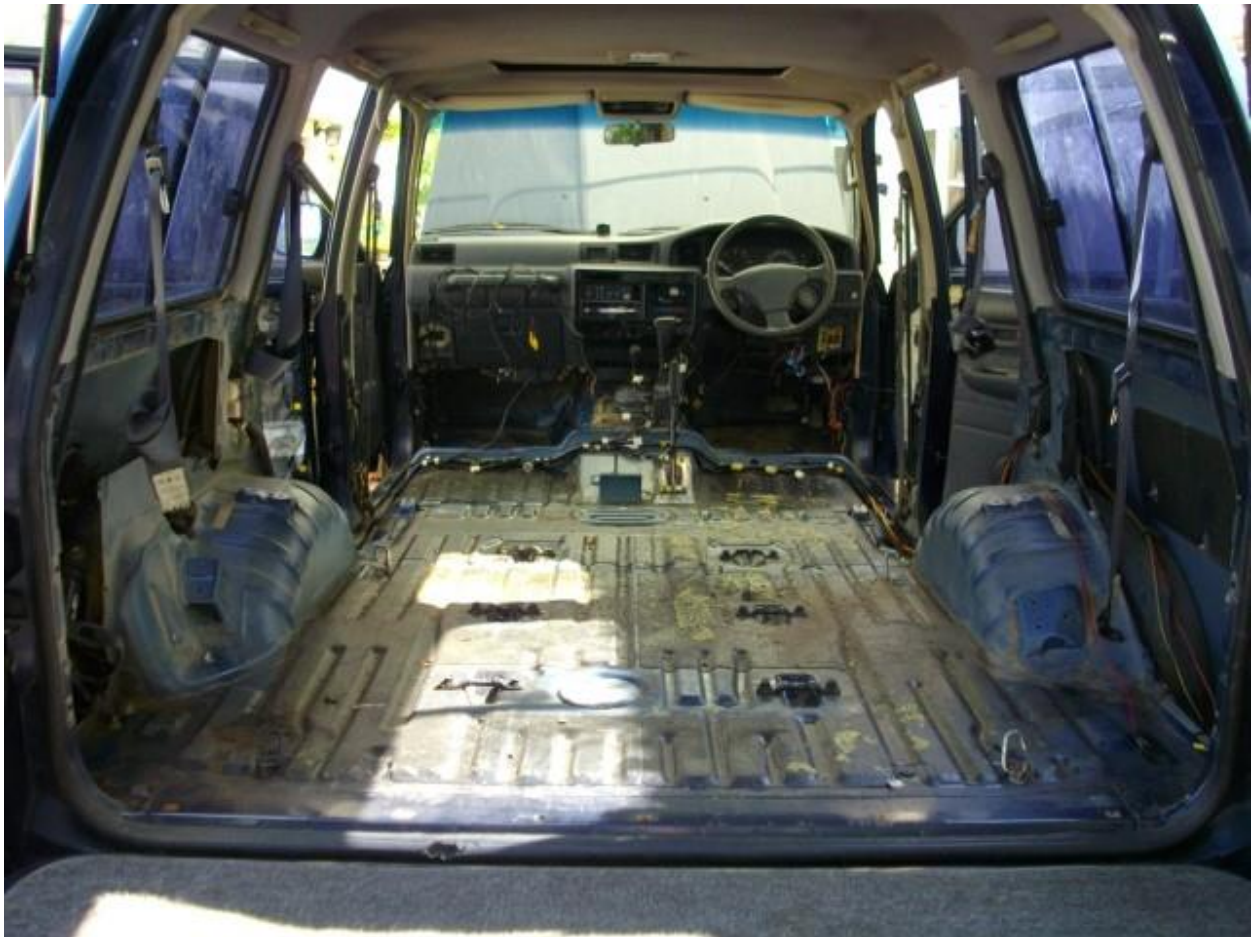
Start with a total strip out ... toss the old factory underlay but keep the bitumous areas intact

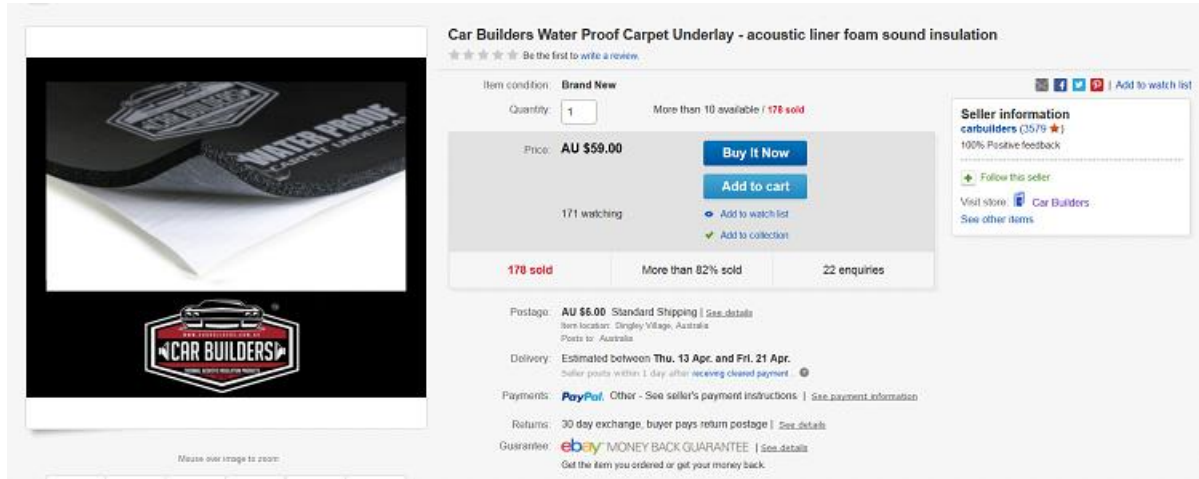
## Check out Ebay for this

3 boxes will cover all the floor area + the rear wheel arches if you utilize the small offcuts wisely

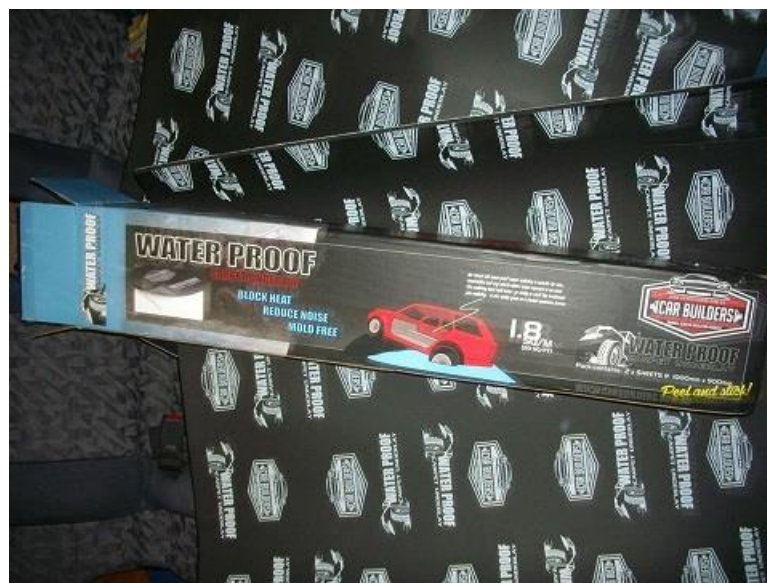
Easy to cut , peel and stick. Don't forget to cut openings for such things as seat and seatbelt fixing points , rear seat attachment bars etc., as you go.
